Thermal Imaging of Detached House Belonging to

Mr and Mrs Runge

14 Rue Engelhardt
L-1464 Luxembourg – Cessange

Planning & Energy Department

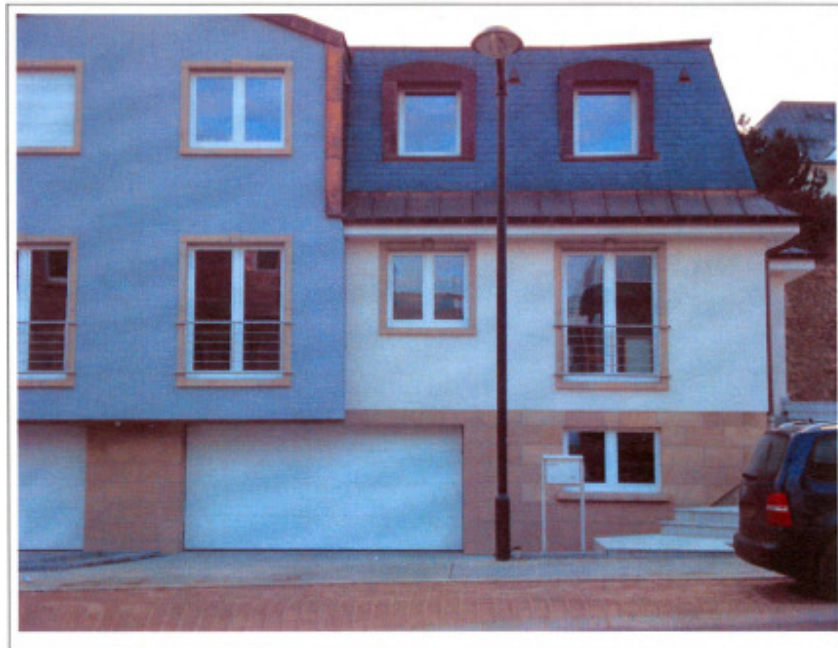
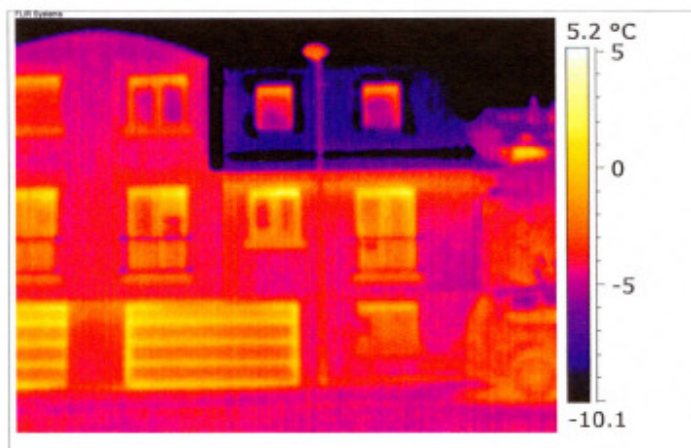
Appendix 1/5

No visible thermal bridge or heat loss. The temperature is homogeneous across the whole of the façade.

The temperature of the window glass and window frames is higher on the thermal images, due to the reflection of the horizon, and also to the fact that the window frames are always the least efficient part of the skin of a building.

Main frontage

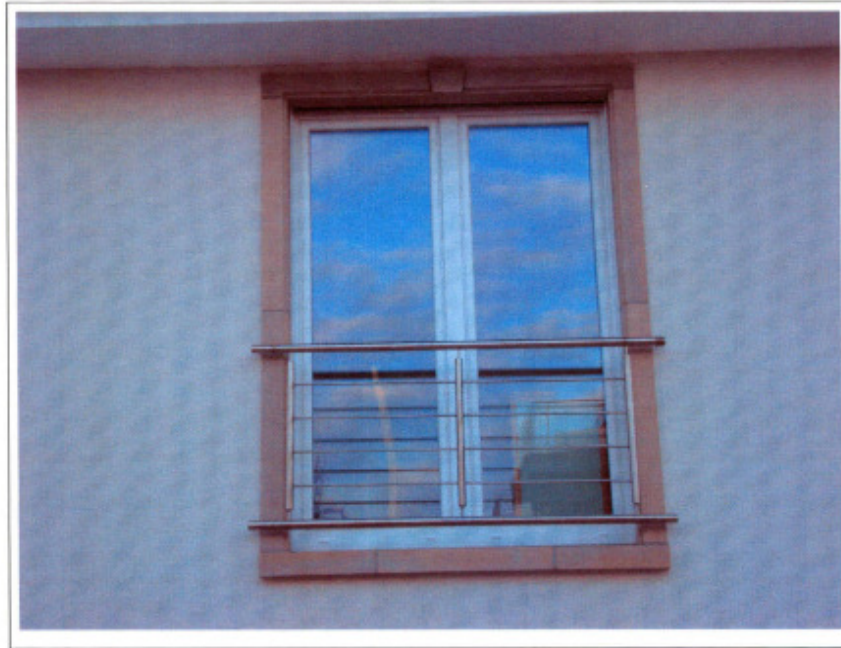
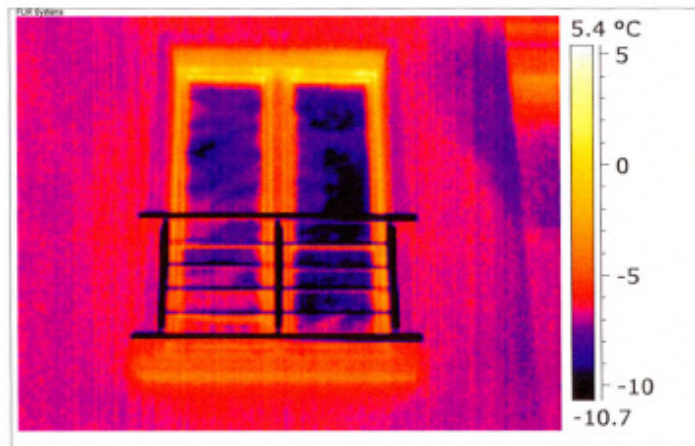
Appendix 2/5

Window glass on main frontage

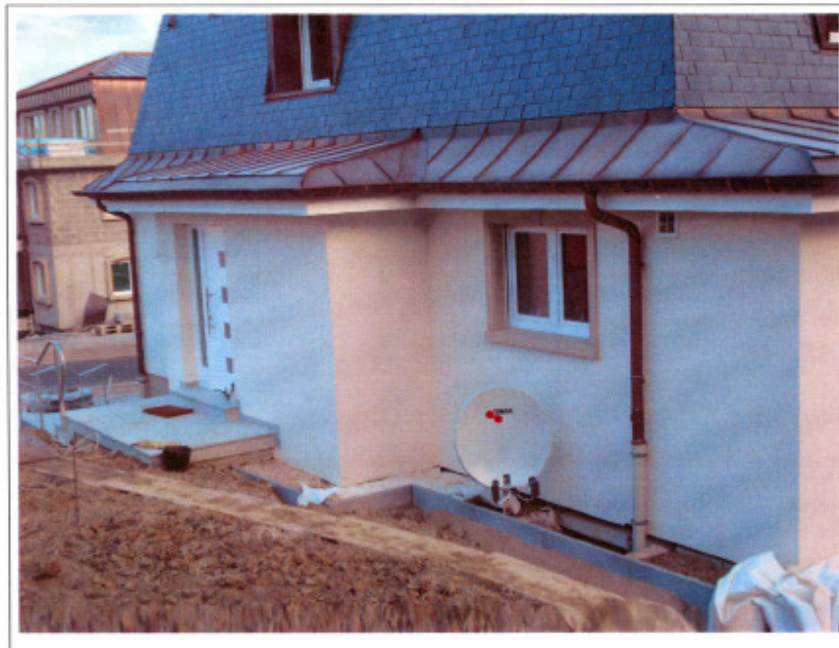
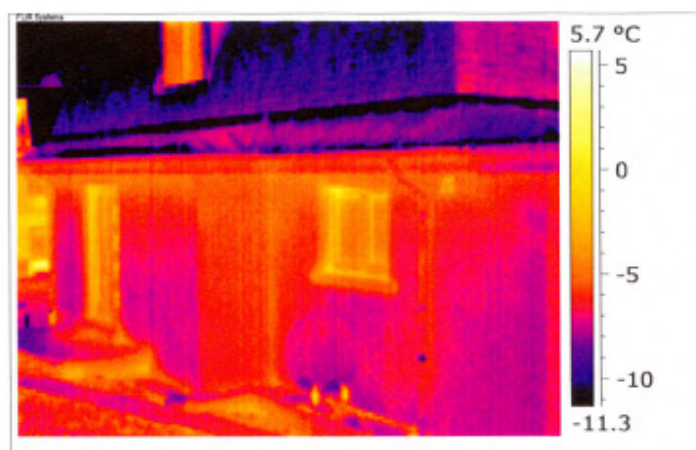
Appendix 3/5

No deficiencies apparent. The temperature is homogeneous across the whole of the façade.

For the same reasons as mentioned above, higher temperatures were noted in the window frame areas.

Right side

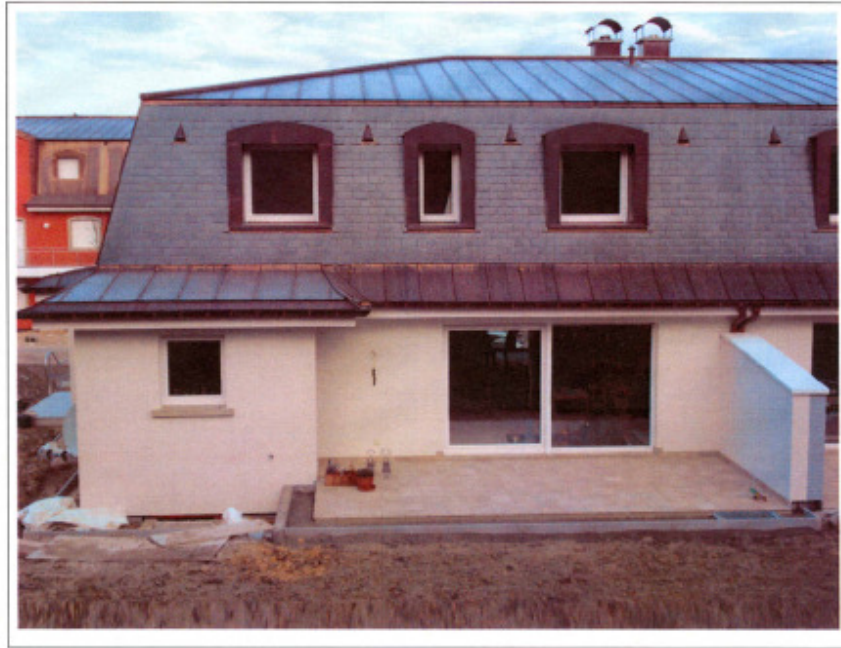
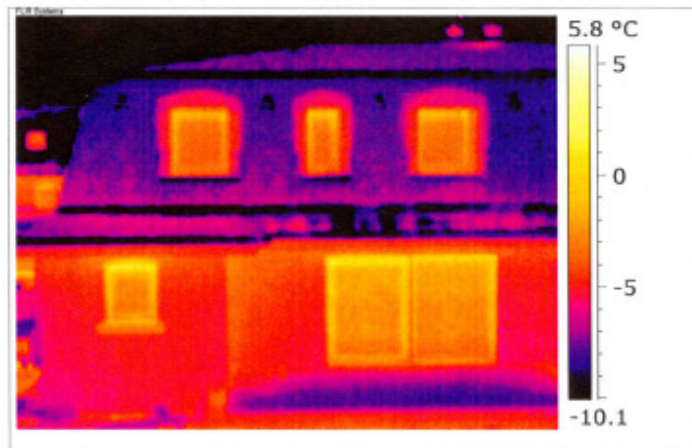
Appendix 4/5

Once again, no problems to be mentioned and the same comments as above apply regarding the window glass and frames.

Rear

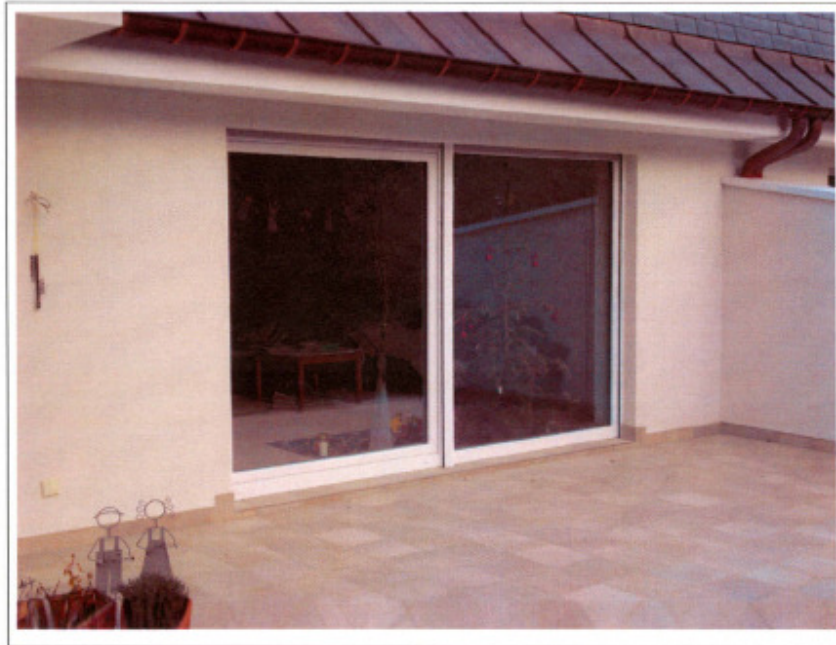
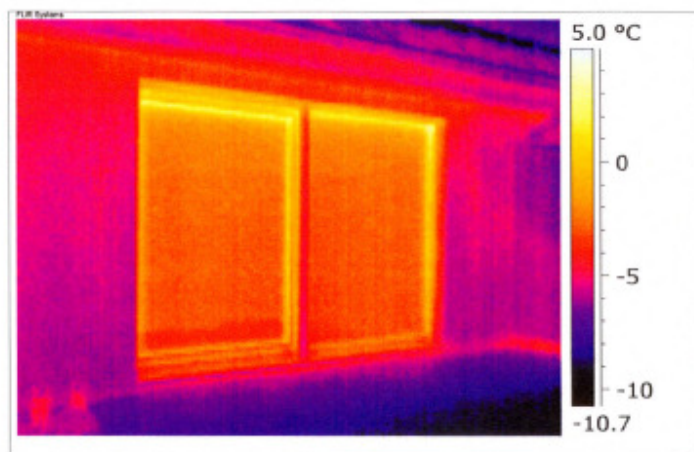
Appendix 5/5

Window glass at rear
